Survey No. F-8-120
Reisler Farmstead
Libertytown, Maryland vicinity
Frederick County

State Historic Sites Inventory Form

historic Reisler Farmstead

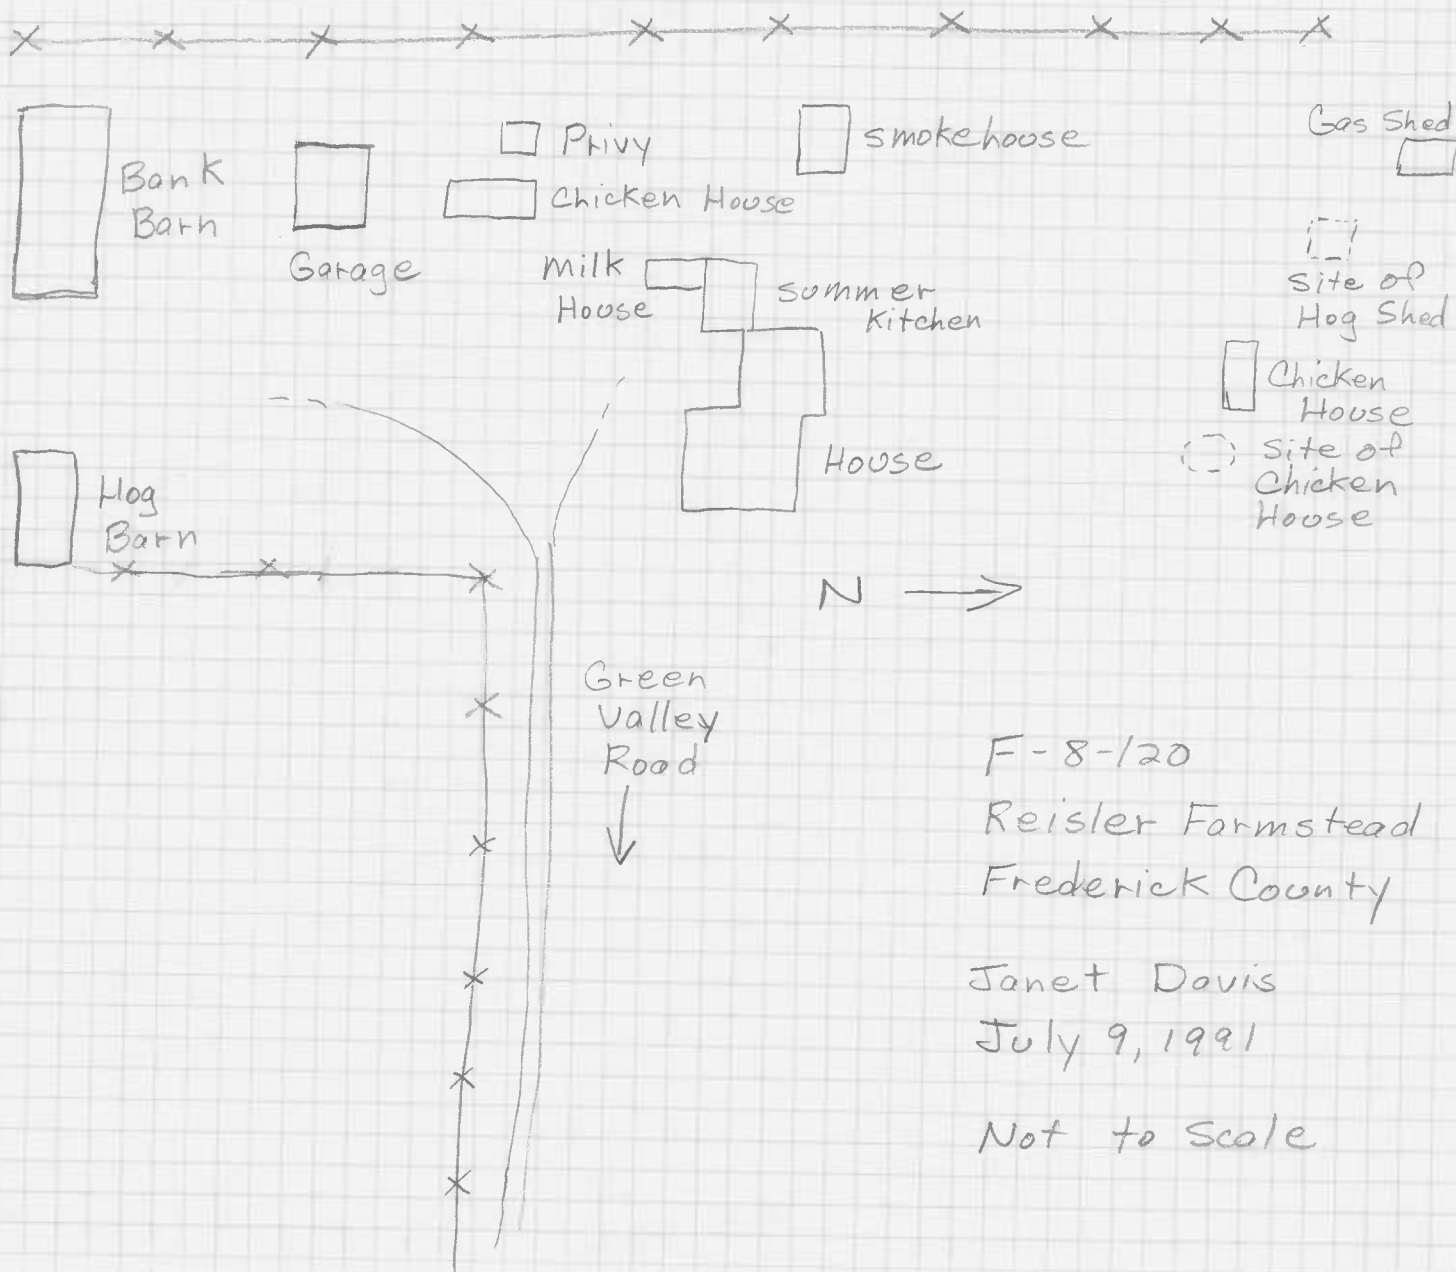
F-8-120

Reisler Farmstead
Frederick County

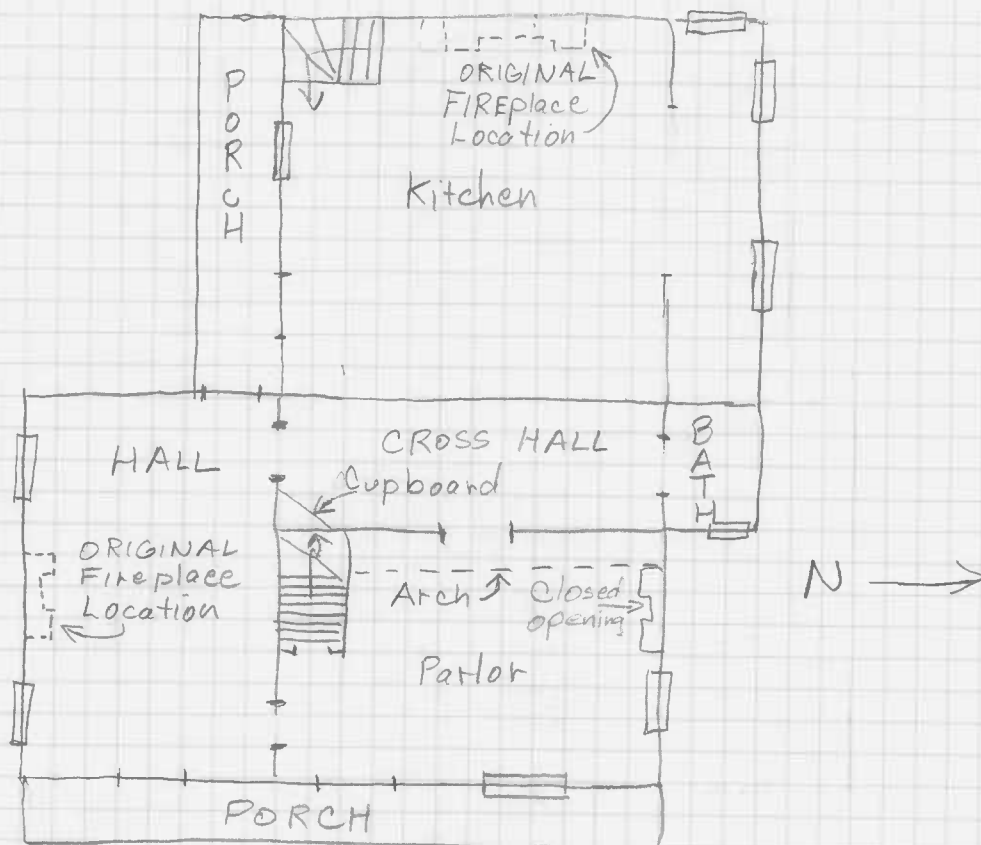
F-8-120
 Reisler House
 Frederick County

The plan of the house is basically a side hall type, with the variation of the two entrances in the east elevation. The staircase is on the interior wall of the parlor rather than in the hall. At the rear of the parlor is a cross hall connecting the side hall and the entrance to the ell. An extension of the single space in the ell is located on the north side of the ell. A corner stairway is located on the southwest corner of the ell. The main hall has grained wood four-panel doors and grained plain architraves on the window and door surrounds. The walls are plaster under mid-20th century wallpaper. On the south wall of the hall is the outline of a stovepipe opening in the location of the original chimney and fireplace opening. No other evidence of the fireplace is visible. The parlor has grained wood trim and a simple paneled mantel on the north wall. The fireplace opening is closed. A plaster elliptical arch drops from the ceiling at the rear of the room and the outline of a stovepipe is visible in the northwest corner. This may indicate a possible altered double parlor floor plan, but further research is needed to clarify the plan. The staircase is enclosed and accessible through a door at the foot of the stairs. The cross hall at the rear of the main section has plaster walls and a wide board floor. Similar floors in the side hall and parlor are covered with carpeting. A corner cupboard with plain paneled doors is located on the southeast corner of the cross hall, backed by the stairs in the parlor.

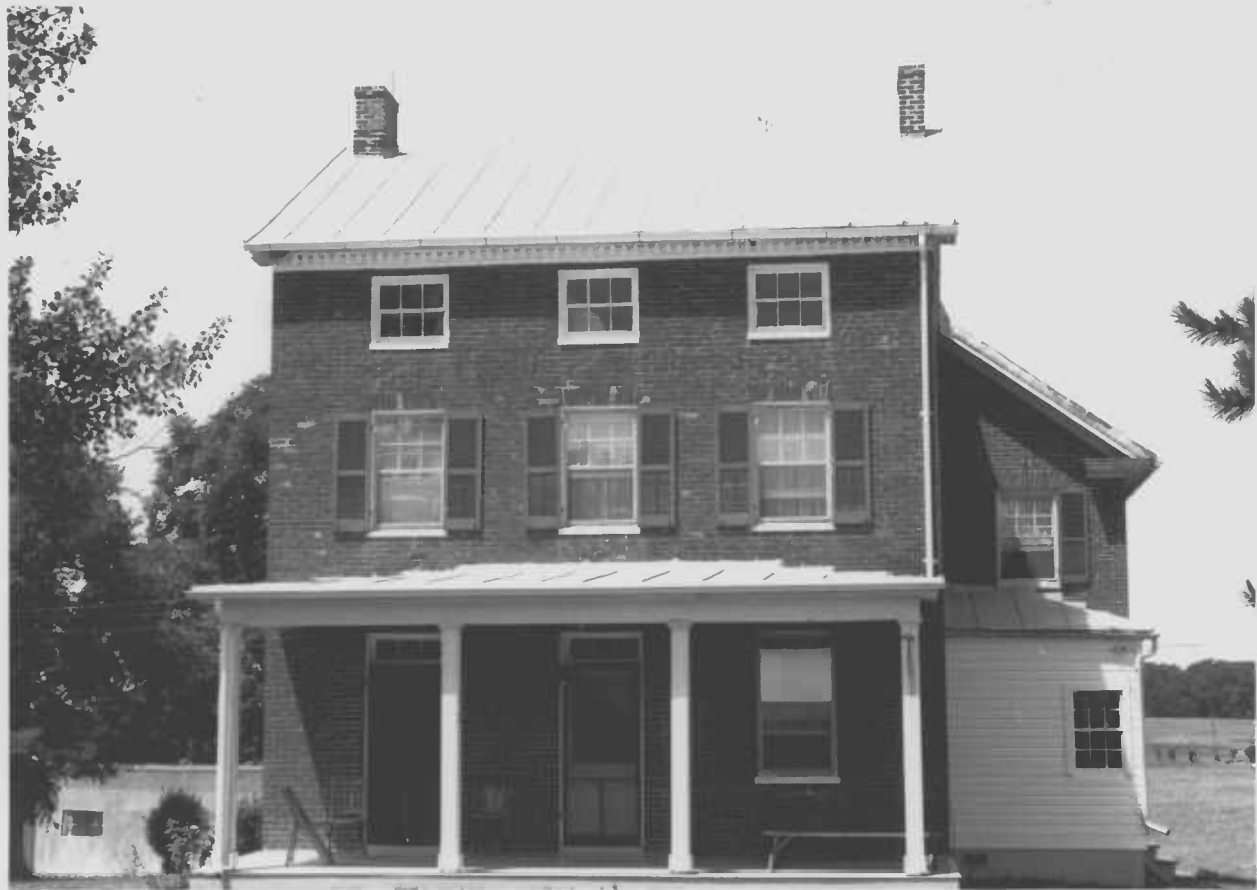
1/10

East elevation

The dwelling house is a 3-bay brick building in 7-course American bond with interior end chimneys, a standing seam metal gable roof and a stone foundation. It has a one-story porch on the east elevation and a two-story porch on the south elevation of the rear wing or ell which extends from the northwest corner of the main section. The windows are 6/6 on the first and second stories and 3/3 on the top half-story which is the attic. There are two doorways in the east elevation in the middle and south bays, each having a three-panel door with a glazed upper panel and a three-light transom. The porch has four square columns and a concrete platform, a replacement of the original wood deck. The cornice is corbelled brick. The north and south elevations each have two window bays flanking the chimney. On the north elevation, the west bay has been enclosed by a frame, horizontal wood-sized structure, which is a bathroom added in the mid-20th century. The rear wing or ell is two stories in height. The south elevation of the ell has an open two-level porch with a plain balustrade on the second floor. At the west elevation of the ell is a central projection rising the height of the house which encloses the chimney of the kitchen fireplace. The wood cornice of the ell's roof extends around the chimney stack with returns on the west face.

The clear definition of the half story in the east elevation suggests the facade of an urban house such as those in the Frederick City Historic District rather than a farm dwelling.

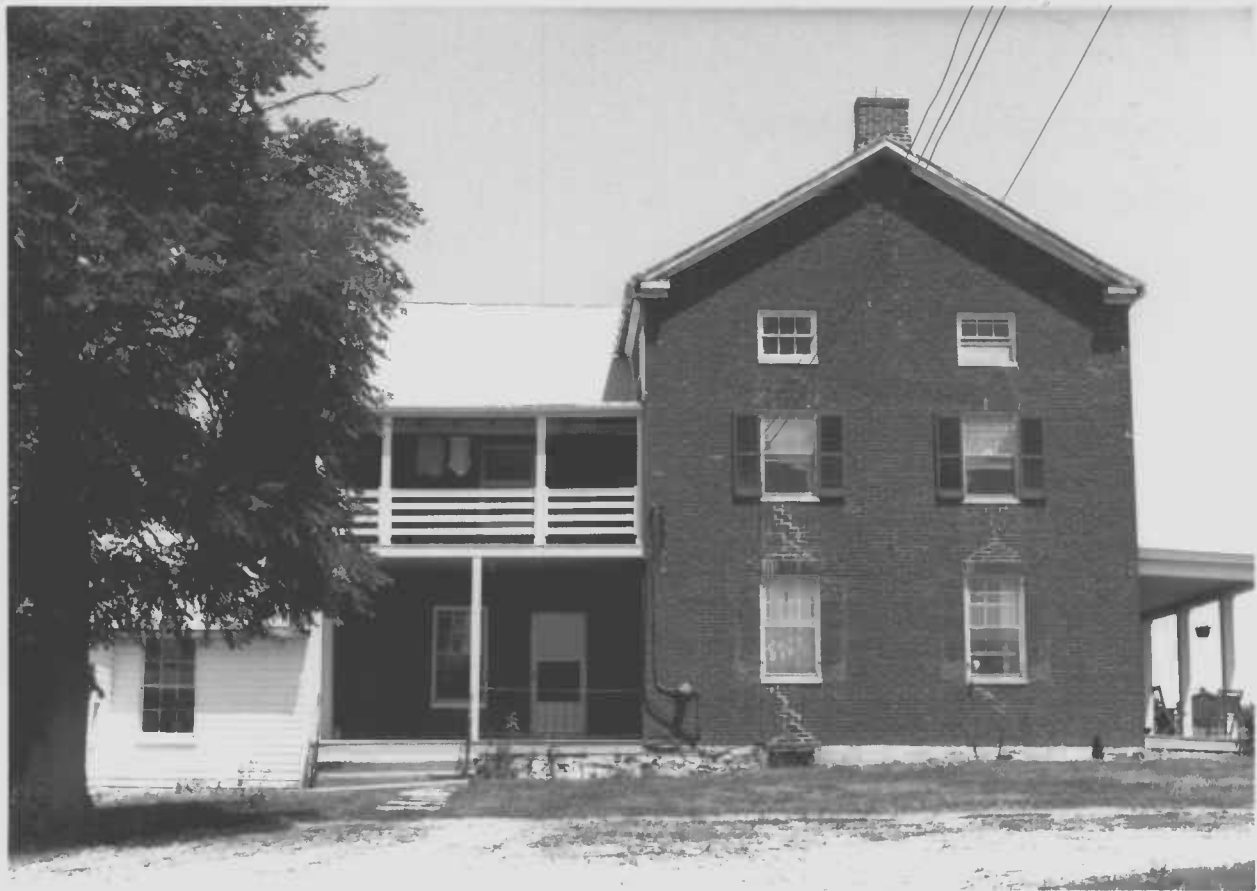
2/10

South elevation

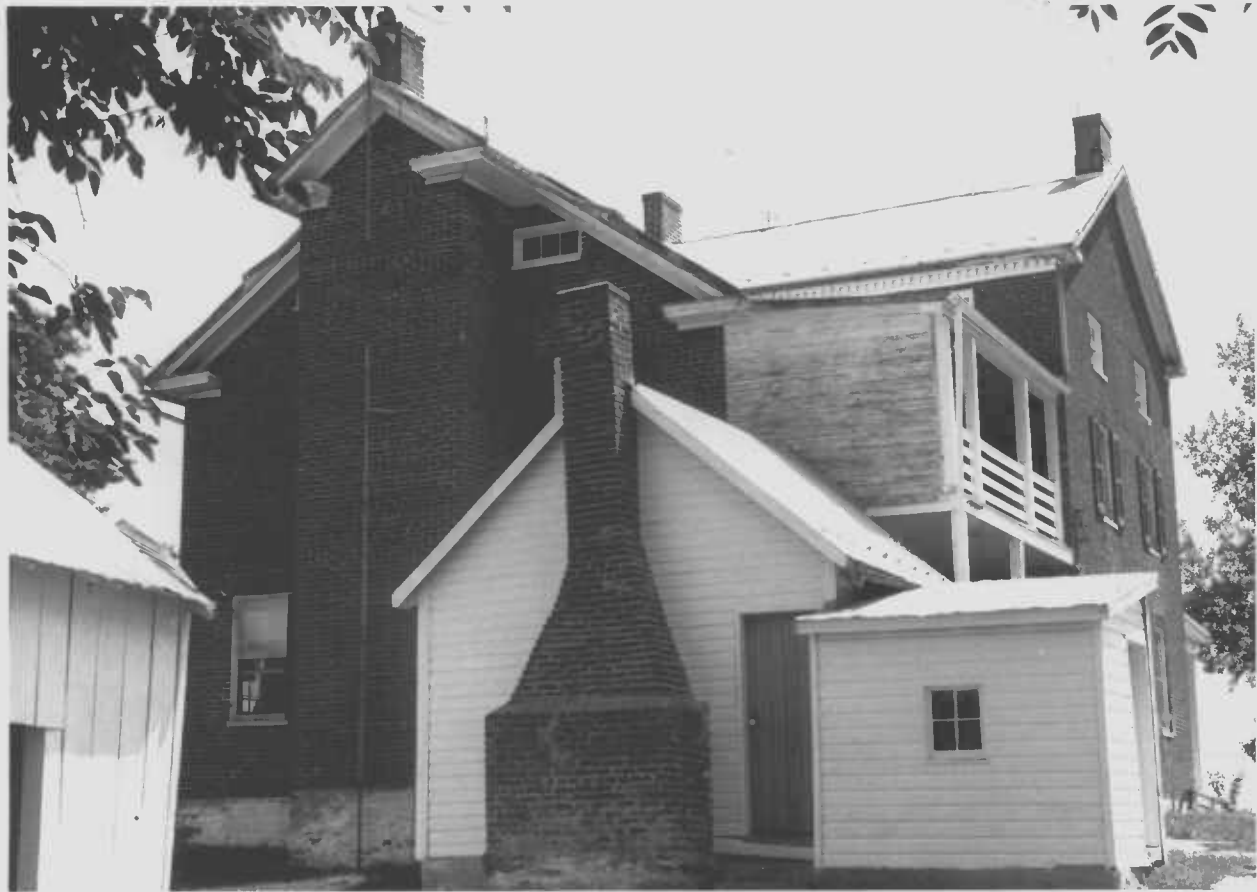
3/10

West elevation and summer kitchen and
- milk house

Summer kitchen: The frame summer kitchen is a one-story structure adjoining the west end of the porch on the house ell. It has german siding, a corrugated metal roof, and an exterior brick and stone chimney on the west gable end. The interior has a tongue-and-groove horizontal paneled wainscot, vertical flush board doors in each gable end, and a plain wood mantel over the fireplace opening. The building appears to date from the 1850's.

Milk house: Adjoining the summer kitchen on the south elevation is a small roughly rectangular frame shed, with a corrugated metal roof and german siding. Small square 2/2 windows are located in the east and west elevations. A vertical flush board door opens in the south elevation. The milk house was used to store sterilized milk cans and was possibly built in the 1920's or 1930's.

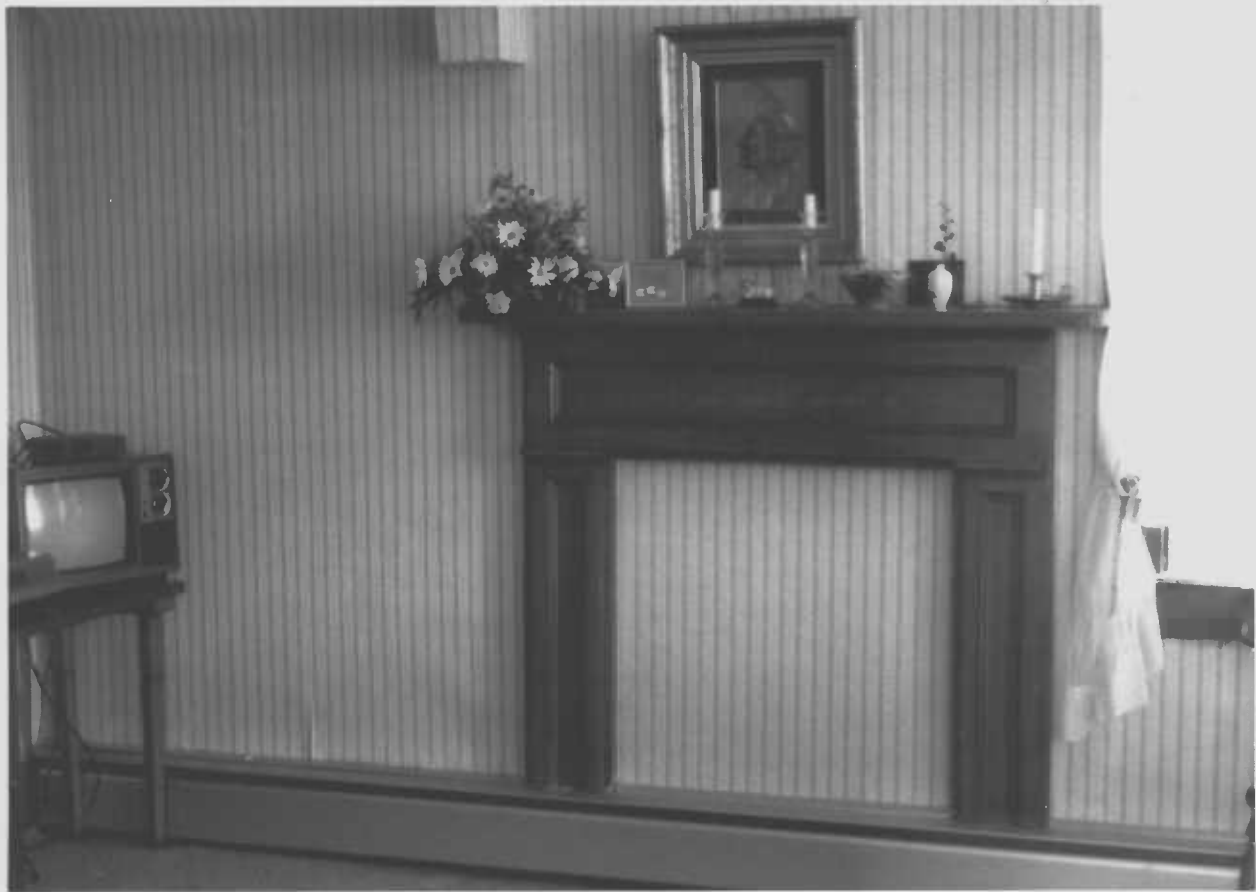
4/10

North parlor mantel piece

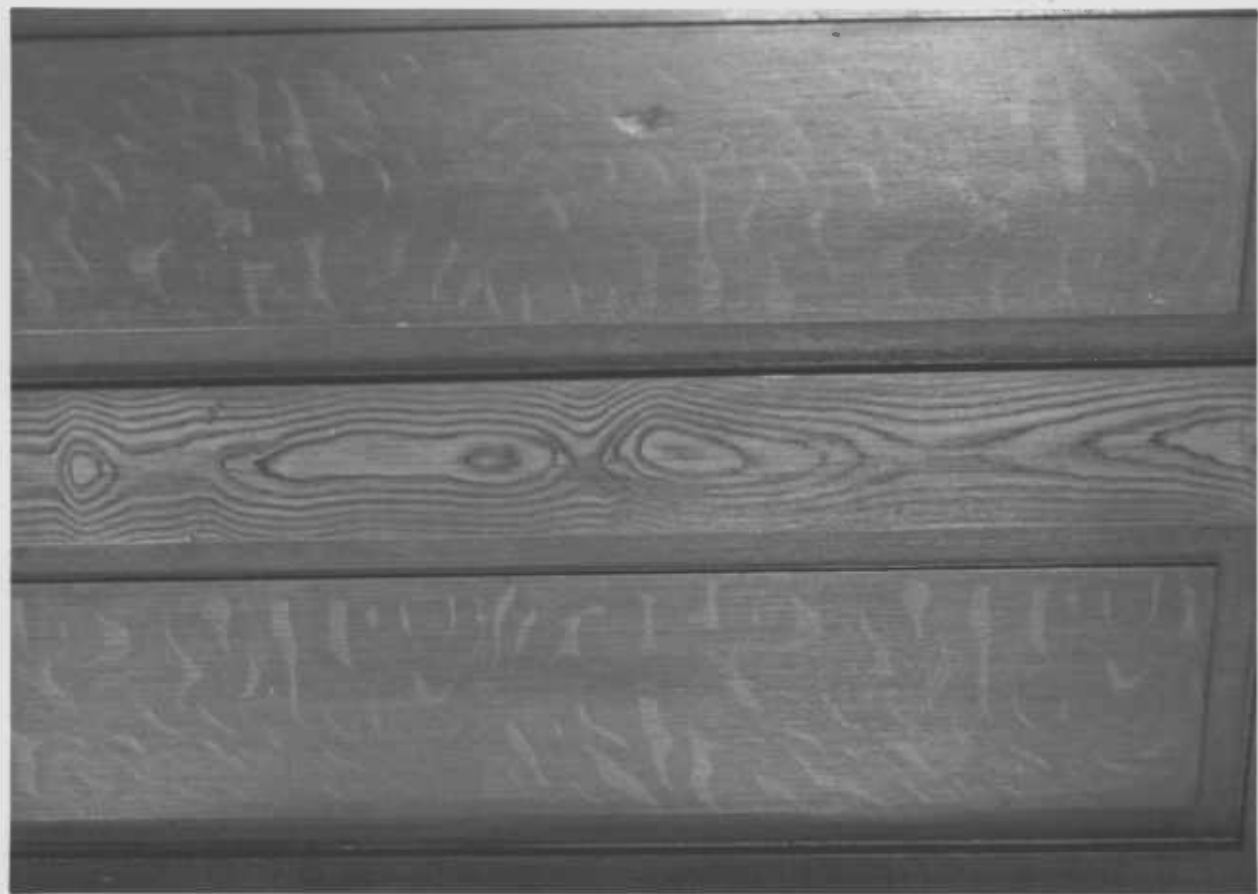
5/10

Stairing detail, main hall

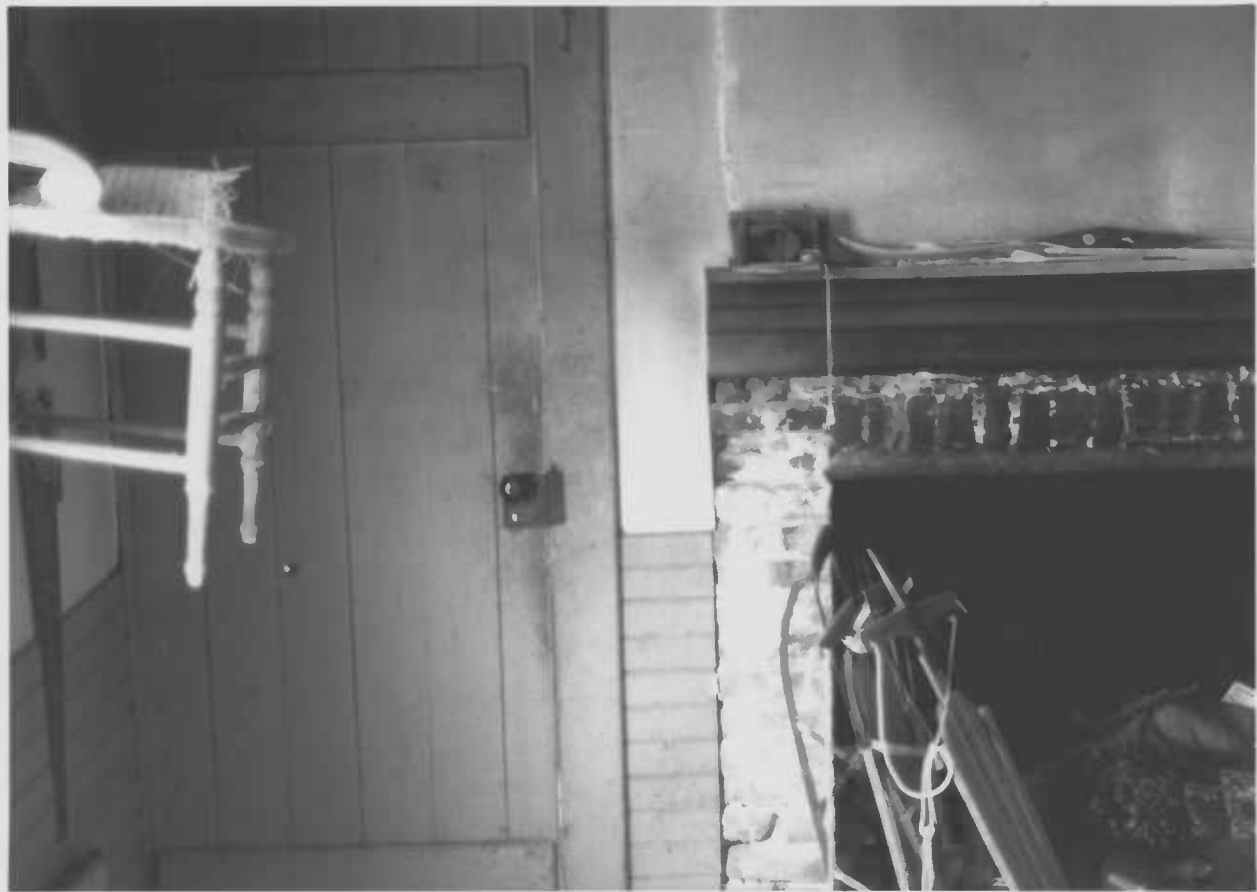
6/10

Summer kitchen interior detail

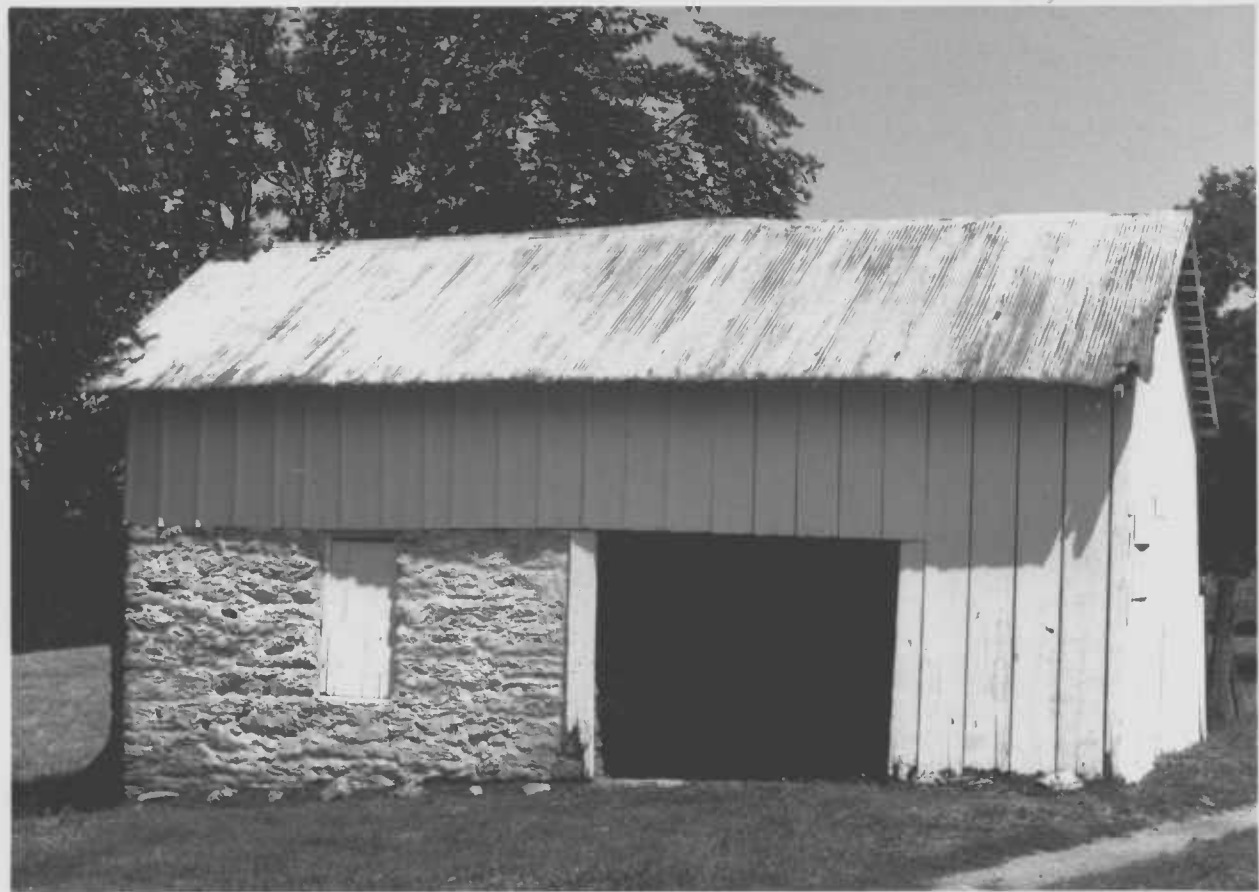
7/10

Smokehouse, south elevation

Smokehouse: The smokehouse is a square stone building northwest of the house. It probably dates from the 1850's. The stone section is topped by a frame upper section which extends eastward from the stone base to form a partially enclosed equipment shed. The frame structure is covered with board and batten siding. The gable roof covering the entire structure is corrugated metal. The interior fireplace in the smokehouse has a massive wood beam over the fireplace opening.

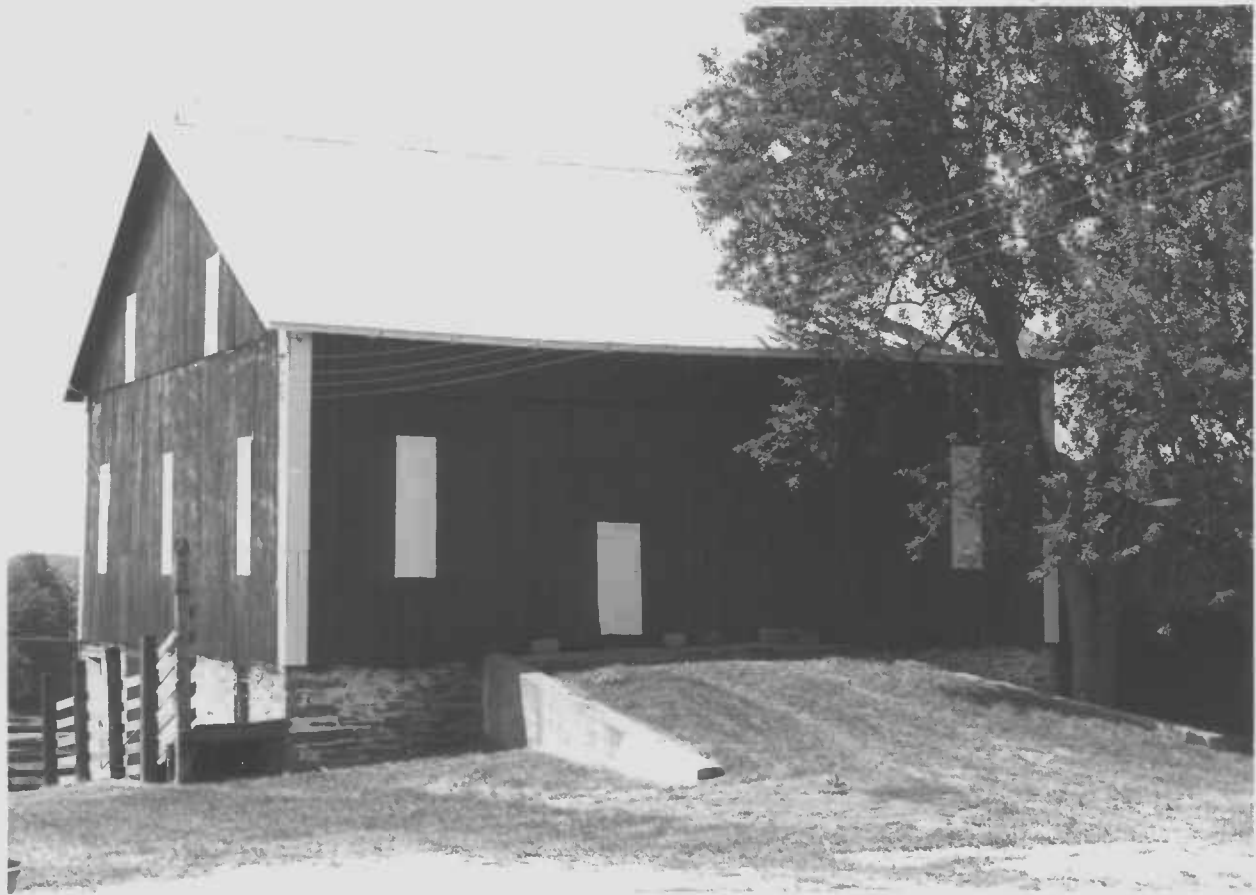
8/10

Bank barn, north elevation

Bank barn: The bank barn was probably built in the third quarter of the 19th century, with vertical siding and some interior structure possibly dating from the last quarter of the 19th century. Metal siding has been applied over the wood siding on the north, east, and west elevations. The forebay on the south elevation and the feeding floor are undivided, retaining double feeding aisles, granaries, and mangers. Niches in the stone end walls for veterinary supplies are visible. The barn has a corn crib and wagon shed on the west elevation.

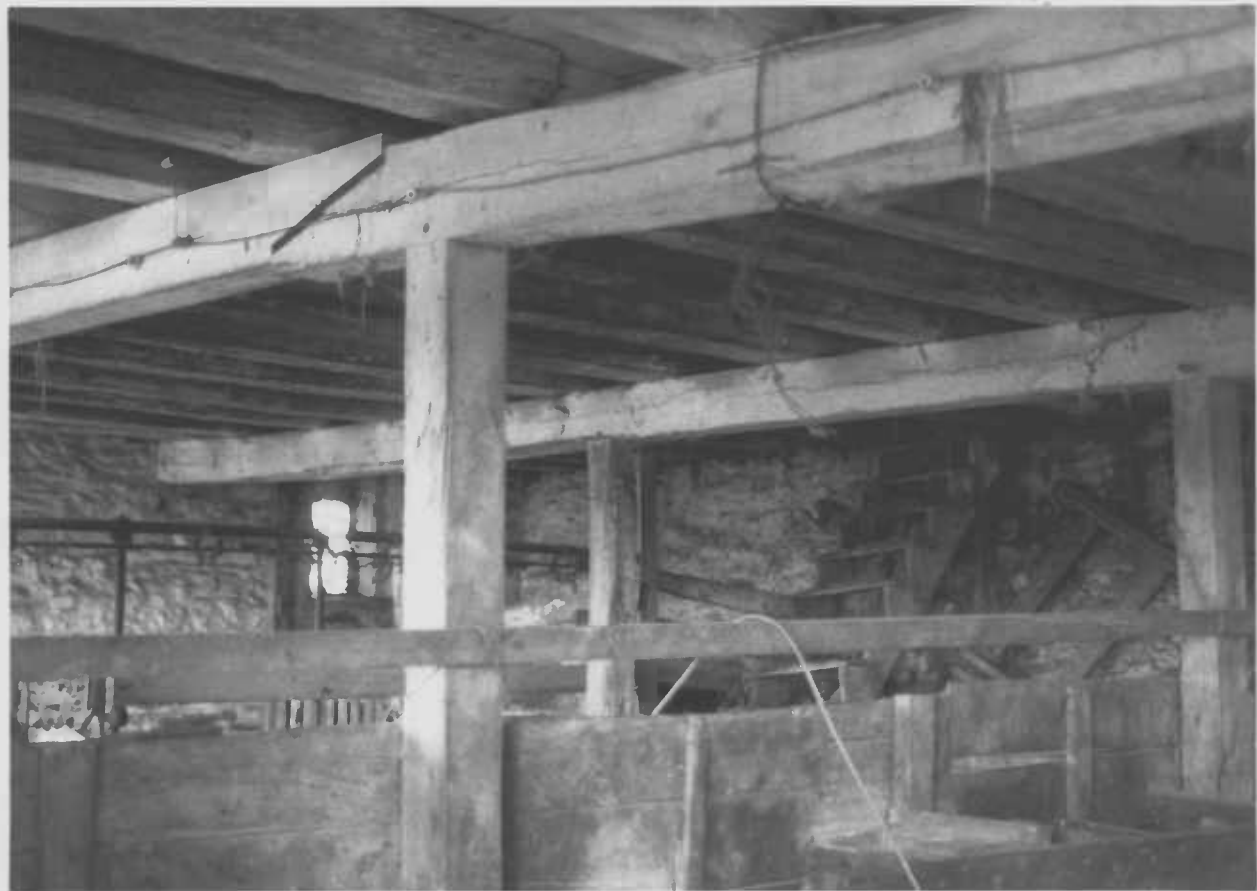
9/10

Bank barn, forebay detail

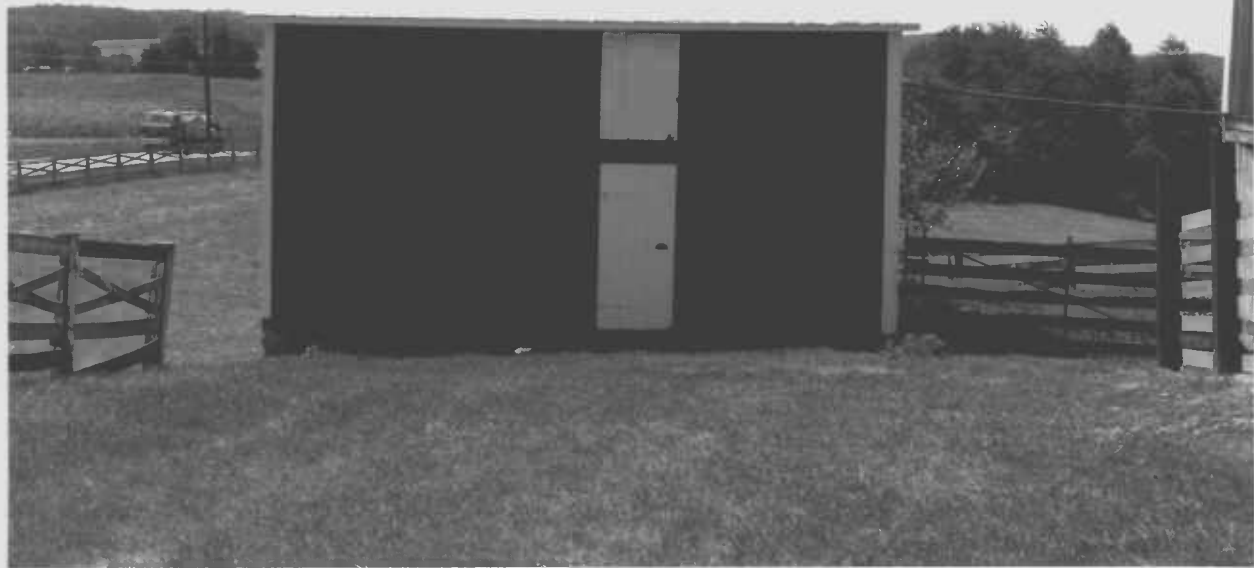
10/10

Hog barn, north elevation

Hog barn: The hog barn was built in the first quarter of the 20th century. It has vertical siding and a gable roof covered with corrugated metal. The plan is typical of small animal barns, with a feeding aisle across its north side and four pens occupying the rest of the building. A concrete block wallow is attached to the south elevation. A single door is located in the north elevation, with a feed door above it.
